# Aviation Investigation Preliminary Report

<b>Location:</b>	Roanoke, VA	<b>Incident Number:</b>	DCA25LA339
<b>Date &amp; Time:</b>	September 24, 2025, 21:17 Local	<b>Registration:</b>	N21129
<b>Aircraft:</b>	Embraer EMB-145XR	<b>Injuries:</b>	53 None
<b>Flight Conducted Under:</b>	Part 121: Air carrier - Scheduled

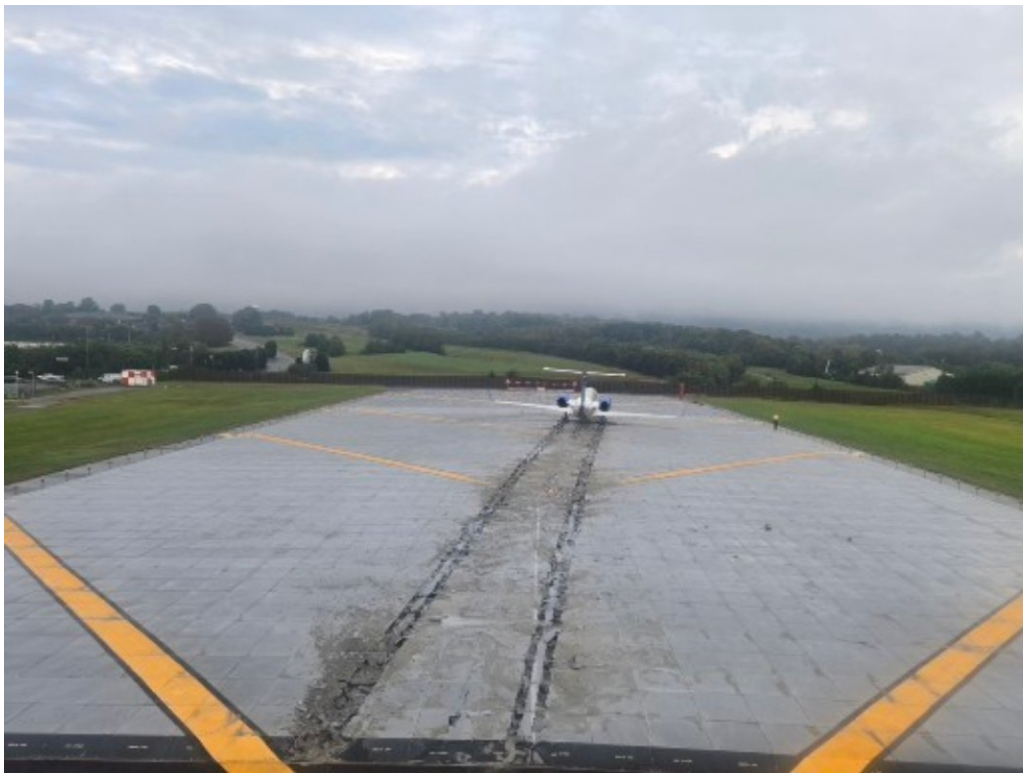
The airplane touched down and the flight crew applied maximum braking and deployed the engine thrust reversers. The airplane overran the end of the runway and came to rest in the EMAS. The FO attempted to communicate with air traffic control (ATC), but the communications button had disengaged. After engaging the communications button, the FO coordinated with ATC and contacted the flight attendant (FA). The FA verified that there were no injuries. The flight crew completed the emergency evacuation checklist and prepared for an evacuation. Airport rescue firefighting (ARFF) personnel boarded the airplane and assisted with evacuating passengers down a ladder.

**Figure 2.** Airplane main landing gear witness marks in the EMAS at ROA. (Source: ROA)
